A COMPARATIVE STUDY OF FIRE SAFETY CONDITION IN THE READYMADE GARMENT SECTOR OF BANGLADESH BEFORE AND AFTER THE RANA PLAZA ACCIDENT

F. Y. Huda^{1*}, M. S. bin Abdul Rani² and Z. Wadud³

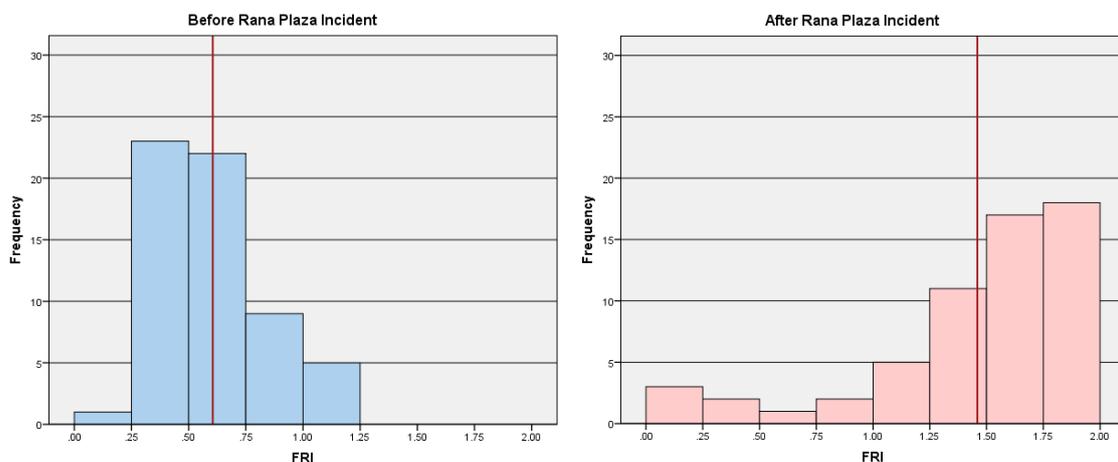
Figure 1. Distribution of FRI's for 60 garment factories before and after the rana plaza incident. Red vertical line indicates the mean FRI.

In FRI grading policy, a higher FRI indicates less fire risks. Thus, our study reveals that for a total of 60 garment factories, the mean FRI after the rana plaza incident is 1.46 on a 2.0 scale while before the incident, mean FRI was 0.61. It should be noted here that the 60 factories which have been surveyed after the incident is not the same factories which were surveyed before the incident. We have found 15 similar factories which have been surveyed by the ACCORD and ALLIANCE and in the previous studies. The rest of the factories, we assume did not sign with either these two bodies or shut down their business. Thus, to compare the before and after scenario, we have considered the same number of factories where the rest 45 factories have been selected based on the similar characteristics (i.e. factory location and size of the factory) of the previous ones.

Figure 1 shows the frequency distribution of FRI of the 60 garment factories for both the scenarios. While no garment factory has achieved FRI more than 1.25 before the incident, after the incident, more than 76% garment factories have achieved FRI 1.25 and above. While 75% garment factories achieved FRI between 0.25 and 0.75 before the incident, after the incident, the percentage is below 10% which indicate that the overall fire safety of the garment factories have improved significantly. Though there are still 8 factories in the sample size which possess 50% deficiency from the ideal case of FRI 2.0.

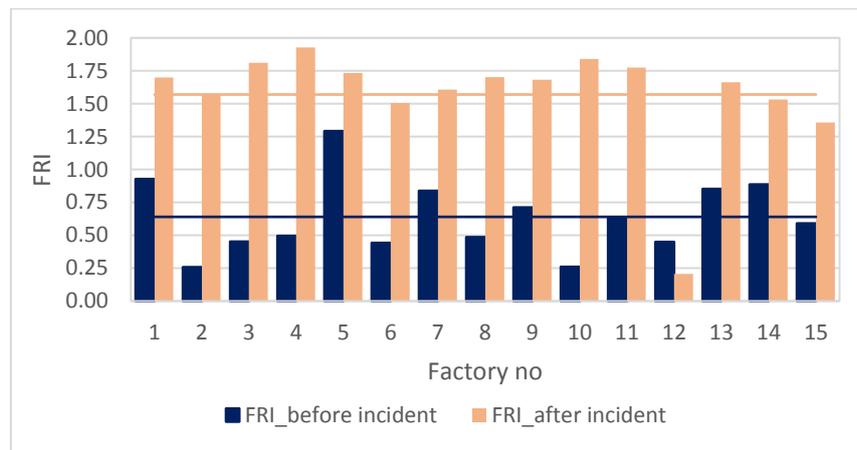
Figure 2. Distribution of FRI's for 15 factories before and after the rana plaza incident. Horizontal line indicates the mean FRI.

Comparing the FRI for the same 15 factories which were surveyed by the earlier studies and also by the ACCORD and ALLIANCE, the mean FRI before the incident is 0.64 which increased to 1.57 after the incident. Figure 2 depicts the distribution of the 15 factories where all the factories except factory no 12 shows an increment of FRI at the present context compared to the previous scenario of rana plaza incident. This also depicts a favorable workplace in terms of fire safety at the present context compared to the previous condition. A closer insight of the inspection report for factory no 12 depicts that for many of the parameters, performance of this factory didn't change, even performed worse for some parameters i.e. exit sign and illumination type, corridor width, etc. at the present context than it was before the rana plaza incident. In terms of five most important parameters (denoted by their weight value), i.e. locked exit (w=5), chemicals (w=4.75), block furniture (w=4.75), fire pump (w=4.38), and boiler room (w=4.13), this factory performance didn't change at all after warning them for several times by the ACCORD.
