Symposium Proceeding on

Safety in Garment Industry, Five Years After Rana Plaza

30 April, 2018

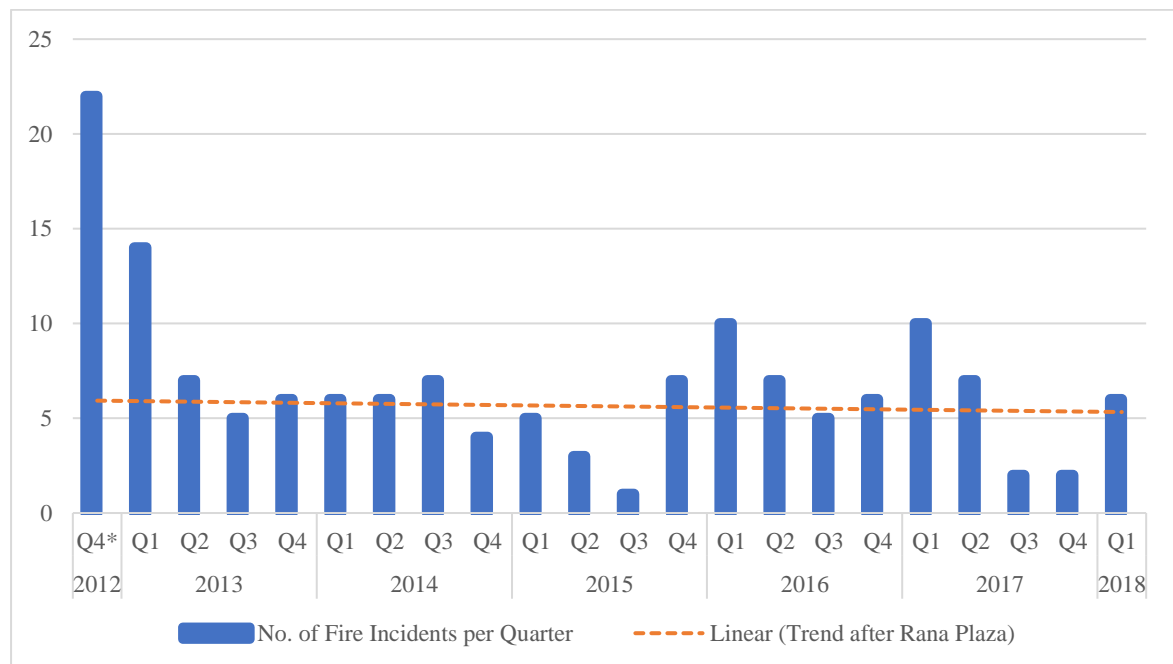
Figure 1: Total of fire incidents in the garment industry in Bangladesh since Tazreen Fire (adapted from solidarity center, 2017)

Figure 1 shows the number of fire incidents per Quarter year since Tazreen Fashion fire until present (April 2018)¹⁹, with a linear trend line for the period after Rana Plaza. The trend in *Figure 1* is downwards, but to a very small extent ($y = -0,03x + 5,96$, $R^2 = 0,0051$). This indicates that the total number of fires is decreasing very slowly. *Figure 2* shows the number of fire incidents per Quarter year since Tazreen Fashion fire until present (April 2018)²⁰ in which at least one person was injured or died, with a linear trend line. The downward trend in *Figure 2* is more pronounced ($y = -0,16x + 4,27$, $R^2 = 0,2908$), indicating that the number of serious fires is decreasing at a higher rate than the overall number of fires. The careful conclusion of *Figures 1* and *2* is, that the number of fire incidents decreases slowly, and the remaining fires also decrease in gravity, but that it is too early to become complacent. Extra efforts to bring down the number of fire incidents are still needed.

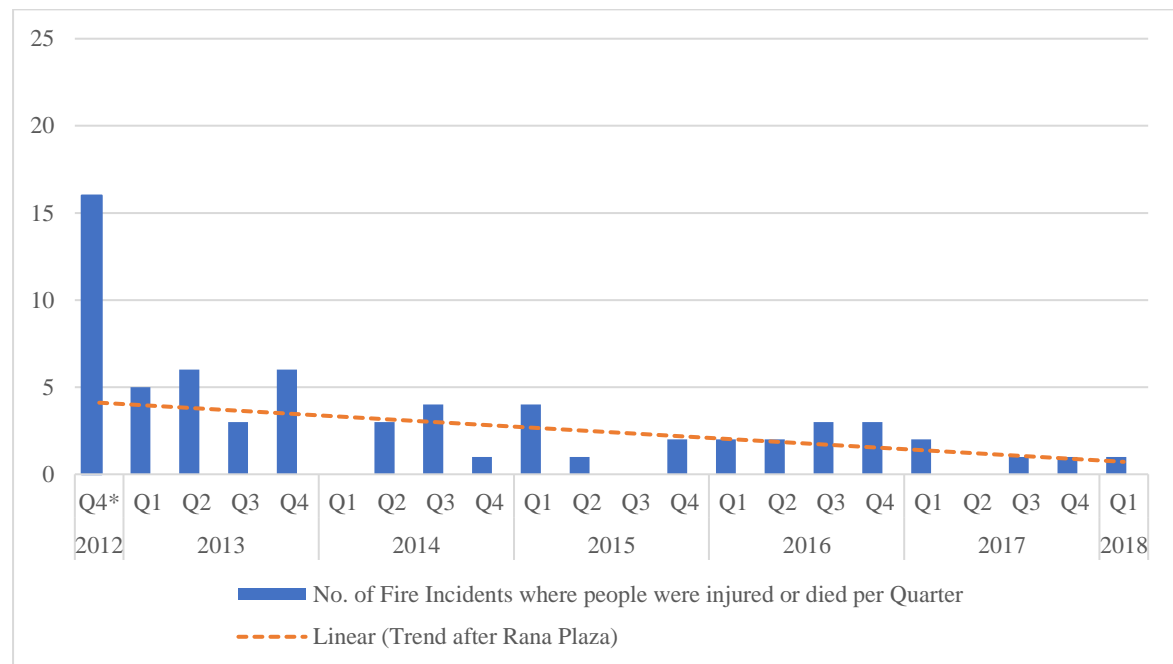
Figure 2 Fire incidents with one or more victims (injured or dead) in the Garment industry in Bangladesh since Tazreen Fire (Adapted from Solidarity Center, 2017)

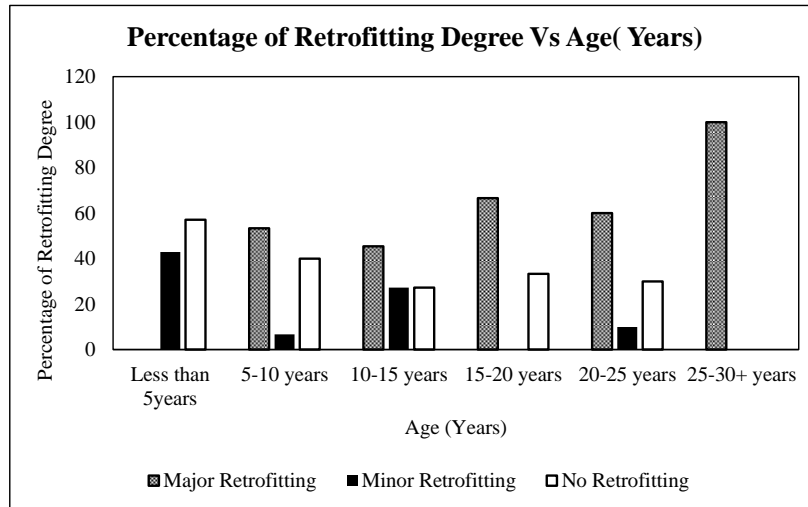
Figure 2. Percentage of Retrofitting Vs Age (Years)

In the data set the age of the buildings has varied from two to thirty three years. The newly constructed ones, with an age of less than five years, almost require no retrofitting. As the age increases the percentage requirement of major retrofitting increases more or less. Most buildings e.g. 22 among 60, fall within the age group of 10 to 15 years, Among these almost 46% require major retrofitting and the percentage for minor or no retrofitting in is 27% each. The maximum percentage of buildings, which require major retrofitting are the oldest ones with an age of 20 to 30 plus years. Figure 2 summarizes this. It can be said that there is also some dependency between the age and degree of retrofitting.
